## PCI-SIG ENGINEERING CHANGE NOTICE

<b>TITLE:</b>	Surprise Down Error & Link Up Additions
<b>DATE:</b>	4 Feb 2004 (updated 10 June 2004)
<b>AFFECTED DOCUMENT:</b>	PCI Express Base Specification Revision 1.0a
<b>SPONSOR:</b>	David Harriman, Intel Corporation

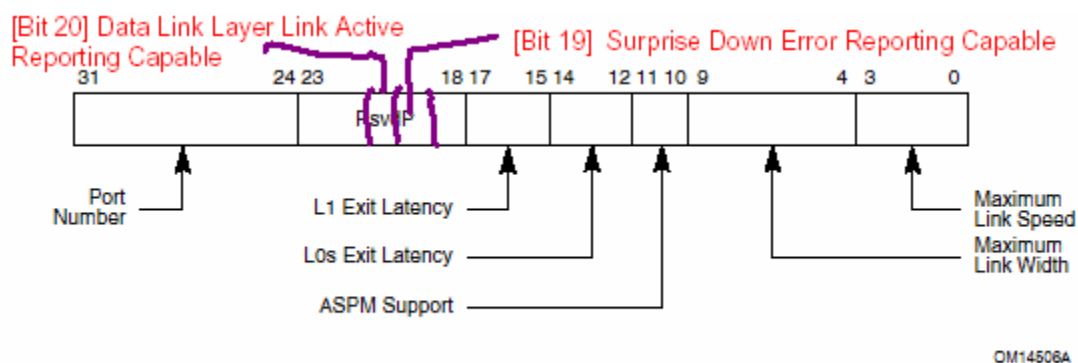
Figure 7-16: Link Capabilities Register

Bit Location	Register Description	Attributes
...		
17:15	...	
<u>19</u>	<p><u>Surprise Down Error Reporting Capable – For a Downstream Port, this bit must be set to 1b if the component supports the optional capability of detecting and reporting a Surprise Down error condition.</u></p> <p><u>For Upstream Ports and components that do not support this optional capability, this bit must be hardwired to 0b.</u></p>	<u>RO</u>

Bit Location	Register Description	Attributes
<u>20</u>	<p><b><u>Data Link Layer Link Active Reporting Capable</u></b> – For a Downstream Port, this bit must be set to 1b if the component supports the optional capability of reporting the DL_Active state of the Data Link Control and Management State Machine.</p> <p><u>For Upstream Ports and components that do not support this optional capability, this bit must be hardwired to 0b.</u></p>	<u>RO</u>
31:24	...

In 7.8.6, Link Capabilities Register:

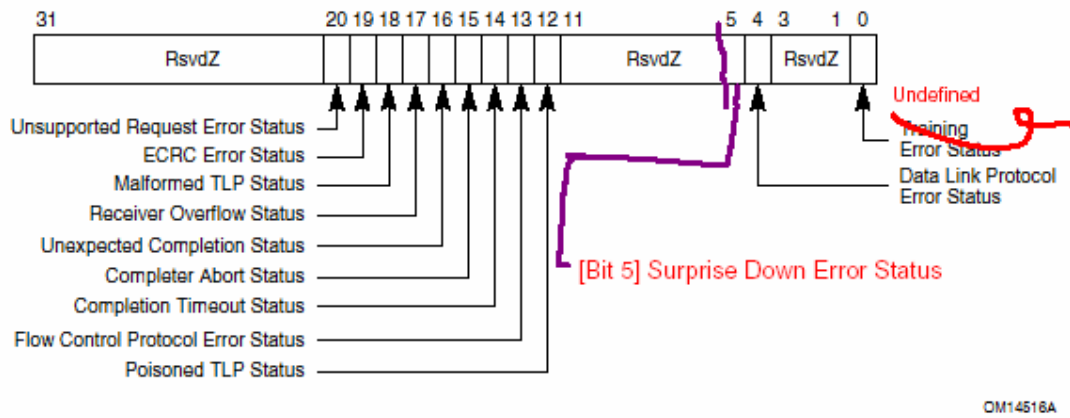
In 7.10.2, Uncorrectable Error Status Register (note: preceding ECN removing Training Error reflected in the markups below):

Bit Location	Register Description	Attributes	Default Value
...			
<u>5</u>	<u>Surprise Down Error Status (Optional)</u>	<u>RW1CS</u>	<u>0</u>
...

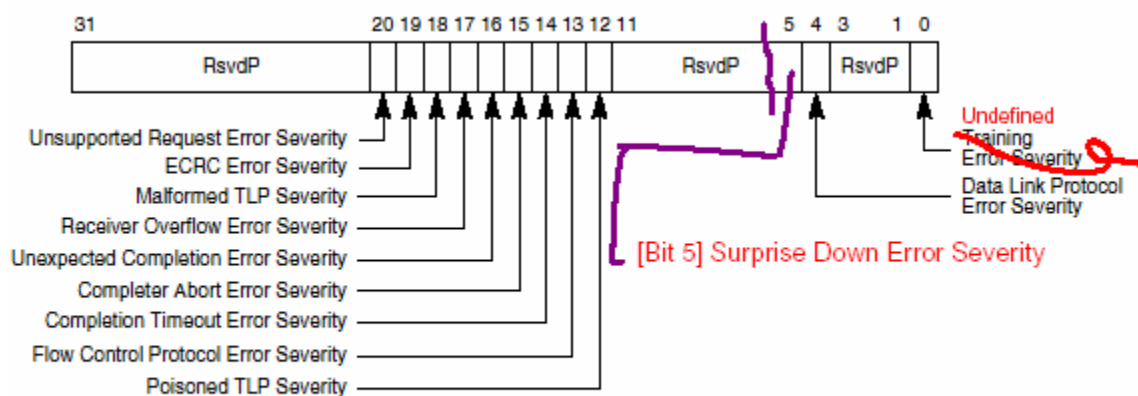
Figure 7-30: Uncorrectable Error Severity Register

In 7.10.4, Uncorrectable Error Severity Register (note: preceding ECN removing Training Error reflected in the markups below):
